**APPLICABILITY OF THE MATHEWS
STABILITY METHOD TO OPEN STOPE
STABILITY ASSESSMENT AT OLYMPIC DAM
MINE**

A thesis submitted in partial fulfilment of the requirements for the

Master of Science in Engineering Geology

University of Canterbury

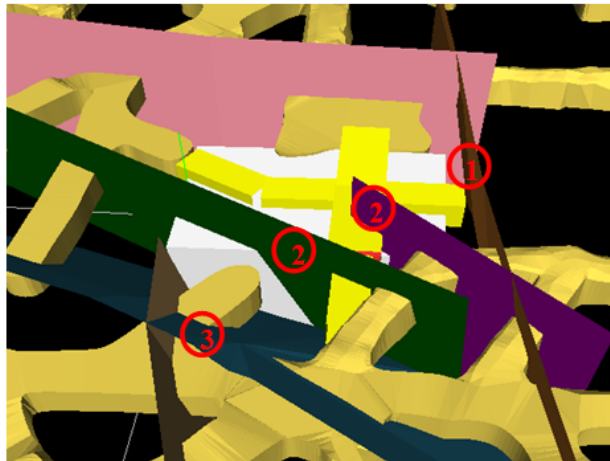
Image displaying Subvertical structure (1) sub-parallel and offset approximately 5 metres from West wall of Blue 117. Subvertical structure (2) intersect Crown and North & East walls. 45° South-West dipping structure (3) intersects North and East Walls below the 45 level.

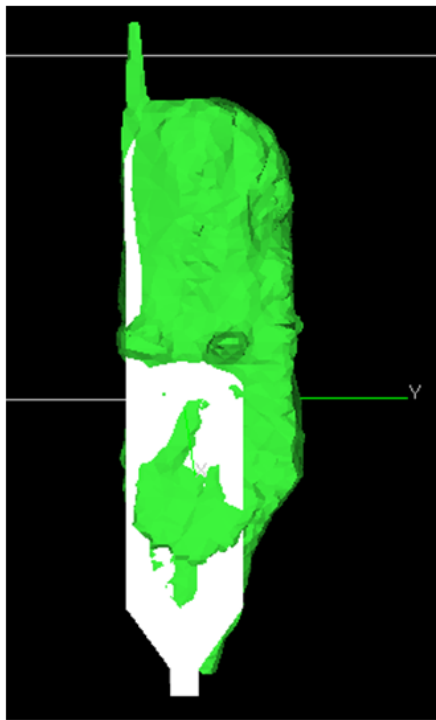
STOPE NAME: Olive 364

Commenced: July 2007 Completed: November 2007 Backfilled:	
Lithology: Formed in HEM & GRNL	
Alteration: No alteration data	
Stope adjacency's: No direct adjacencies	
Stress condition: Moderate	
Overbreak: Both the crown & North surfaces failed	View looking west
Comments: Due to the orientation of the walls with respect to the virgin stress orientation it was acknowledged all the walls would undergo partial de-stressing. This could explain the full level failure of the northern wall.

Comments: This wall experienced overbreak to 81% of it's surface area at a average depth of 8.80 metres. Another plausible explanation could be the arched geometry of the stope crown. The crown also underwent significant failure with 67% of it's surface area over breaking to an average height of 3.30 metres. The presence of volcanics may have effected the crown stability, despite crown cabling. The failure evenly hugs the arch shape of the crown down to the northern wall leaving little explanation for the failure other than the arch shape. The remaining walls of the stope showed minimal overbreak.

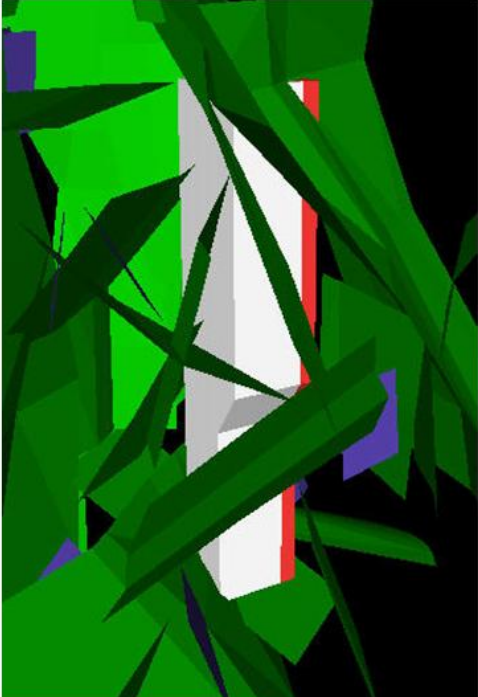
<p>Comments:</p> <p>The crown plotted in the caving zone of the unsupported chart but it was believed cables would be sufficient support to prevent instability. The east wall plotted in the transitional zone, local overbreak was expected.</p> <p>The CMS shows the east wall was stable but the crown of Purple 128 failed, with a maximum overbreak of 7.60 metres and an average of 3.60 metres. The failure appears to be influenced by the overlying development.</p>

View of structures looking north east across Purple 128.
